### LINEAR ACTUATOR REFIT

FRS was asked by one of our customers to repair a pneumatic drive cylinder which was failing in service.

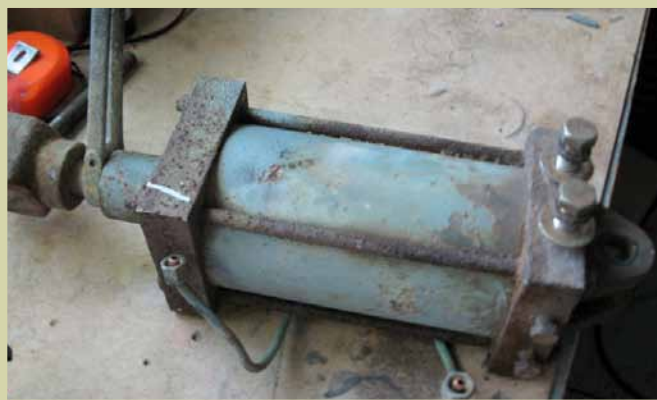
*before*

Once we had a look at the installation we realised that the drive was beyond repair and needed replacing.

The seals on the non-standard cylinder were worn and leaking, the linkage was sloppy and could no longer be tweaked. More importantly there were no spare parts available for the legacy positioner / controller.

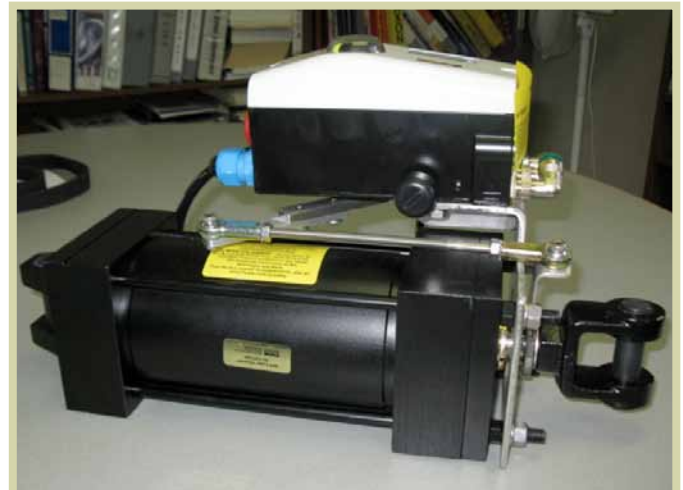
*after*

**The FRS solution was to build our own modern equivalent.**

Our customer received a complete ready to install pneumatic drive cylinder complete with all linkages, brackets, a new air set and filter as well as a "SMART" electronic self-tuning positioner with signal feed back.

**All components are off the shelf... maintenance is no longer an issue.**
